BELZONA PROTECTS SUGAR MILL DIFFUSER FROM ABRASION DAMAGE

ID: 7473

Customer Location: Sugar Mill, Arcis Sur Aube, France
Application Date: November 2016

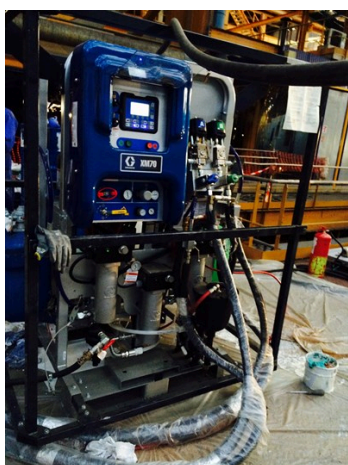
- * Image 1 - The plural airless spray purchased by the Distributor to complete the application ,
- * Image 2 - The sugar diffuser ,
- * Image 3 - QR code for application video ,

The application procedure completed using a modified version of the system leaflet, TCC-5. The application saw 120-150 litres of Belzona 1381 applied to the diffuser at the ideal thickness of 1000 microns. A plural airless spray was used cover the region of over 100m², split into 10m² patches. The application took 5 hours to spray apply but 10 days in total for rotating the diffuser to allow access and for surface preparation.

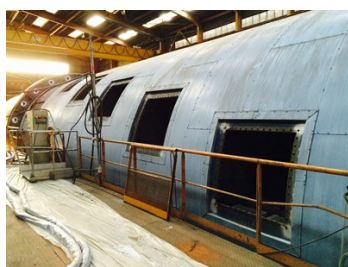
Sugar diffusers are notoriously difficult to protect because they offer limited access. However, they are highly susceptible to abrasion, accelerated by the high temperature of the water (up to 90°C (194°F)) and an added chemical. Therefore, protection is often necessary.

The client was looking for a durable protection of the diffuser. Previously, they had tried different organic coatings and welded stainless steel plates but none had provided satisfactory results. Whereas, after using Belzona 1381 for a year, the diffuser is still in perfect condition with the Belzona coating working flawlessly.
