COLD BONDING PIPE SUPPORTS WITH BELZONA

ID: 7476

Customer Location: Refinery, Shaanxi, China
Application Date: March 2017

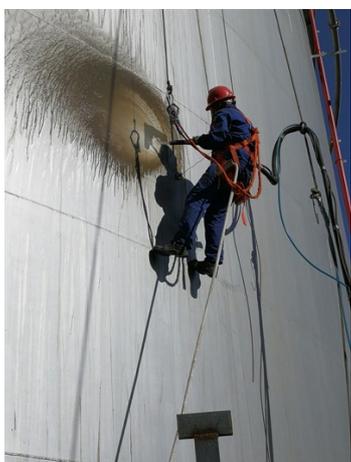
- * 1. Water jet blasting for surface preparation ,
- * 2. Application on top of the tank ,
- * 3. Application on tank wall in process ,
- * 4. Application completed ,

The application was carried out in accordance with Belzona Know-How System Leaflet TCC-6 and VPF-15. To ensure optimum bond whilst observing the safety requirements in the tank farm, surface preparation was conducted using water jet blasting equipment.
