BELZONA SUPERWRAP II APPLICATION AVOIDS WATER SUPPLY INTERRUPTION

Customer Location: Water supply company, Tarragona, Spain

Application: VPF-Valves, Pipes and Fittings

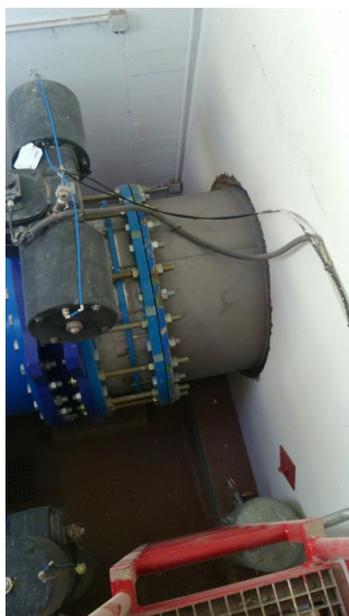
Several pipes were suffering from significant external corrosion due to water leaks occurring through the sealing system between the pipes and the concrete walls of the tanks.

* 1. Potable water pipes of 1300mm diameter to be repaired 2. Surface preparation by grit blasting completed 3. Application of the Belzona Superwrap system underway 4. Job completed ,

The application was carried out by the Belzona Distributor's staff trained and validated to design and apply ISO/ASME compliant wrap solutions. After the application of the Superwrap II system, Belzona 5811 was used to provide a smoother finish to the repair which eventually was coated with a blue polyurethane coating following the customer's specification for water pipes. The Concrete wall was rebuilt with Belzona 4131.

Customer wanted an ISO/ASME compliant repair system able to stop the corrosion, return the mechanical strength back to the pipes and designed to provide a 20 year lifetime. The application online of the Belzona Superwrap II system avoided any water supply interruption. More than 30 other smaller compliant repairs were carried out at the same facility with Belzona Superwrap II.
