# BELZONA BONDS BEARING PADS ON TIDAL TURBINE

Customer Location: Tidal energy developer, Inverness, Scotland

Application: VPF-Valves, Pipes and Fittings

Substrate: Steel and Orkot composite bearing pads

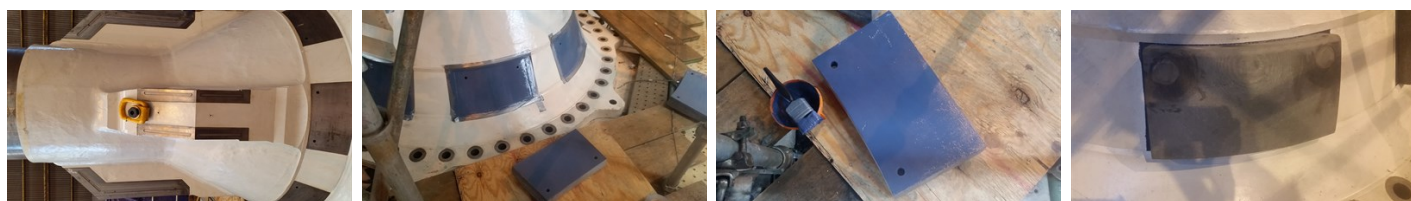
- \* 1. The stab prior to application of bearing pads ,
- \* 2. Wetting out the area ,
- \* 3. Application of Belzona 1321 on to bearing pads ,
- \* 4. Bearing pads bonded in place with bolt holes filled ,

Application was carried out in accordance with a modified version of Belzona System Leaflet VPF-15. The areas to be bonded were fully grit blasted and degreased in accordance with Belzona surface preparation protocols before the bearing pads were bonded into position using Belzona 1321. These were accurately located using screws and keyways. Subsequently, the bolt holes were filled using Belzona 1121, adding further protection.
