PRECISE ALIGNMENT APPLICATION WITH BELZONA 7111 IN COAL MINE

ID: 7498

Industry: Mining & Quarrying
Application: GSS-Gaskets, Seals and Shims
Substrate: Metal Base Plate and Concrete Foundation
Products: * Belzona 4151 ,
* Belzona 7111 (Industrial Grade) ,

Customer Location: Colstrip, Montana
Application Date: May 2017

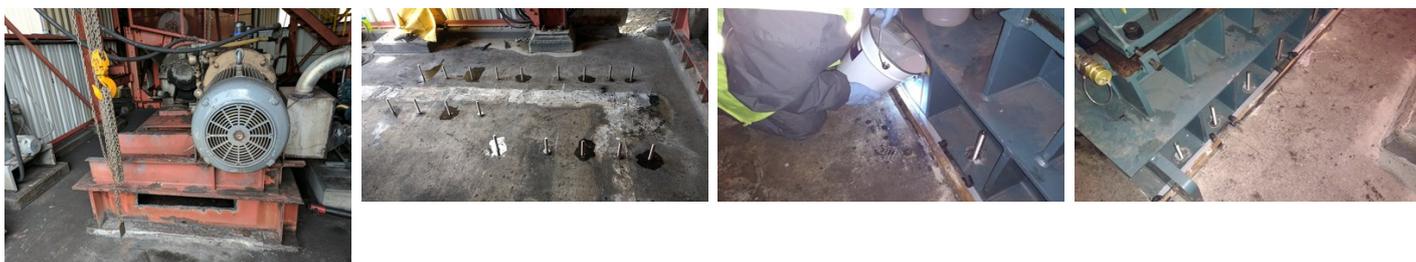
Photograph Descriptions

- * 1- Old CST Drive ,
- * 2- Anchored Bolts with Belzona 4151 ,
- * 3- Pouring Belzona 7111 ,
- * 4- Finalized Application ,

Holes were drilled on the concrete to place the bolts that were going to be used to align and torque the machine. The bolts were anchored using Belzona 4151. A template of the baseplate of the machinery was used as a guideline to install the backer rod on the concrete floor before the actual placement of the machine. The number of chocks and length were all in accordance with the Belzona design specification. Belzona System Leaflet GSS-13 was used to set up and apply Belzona 7111 to precisely align the equipment.

The Belzona solution allowed the mine to replace the drives within their scheduled downtime, the CST drives were aligned and ready to be put back in service in 36 hours. The CST motor drives the main conveyor belt of the plant, so without the conveyor the
