# PRECISE ALIGNMENT APPLICATION WITH BELZONA 7111 IN COAL MINE

**Industry:** Mining & Quarrying  
**Application:** GSS-Gaskets, Seals and Shims  
**Substrate:** Metal Base Plate and Concrete Foundation  
**Products:** \* Belzona 4151 ,  
\* Belzona 7111 (Industrial Grade) ,

**Customer Location:** Colstrip, Montana  
**Application Date:** May 2017

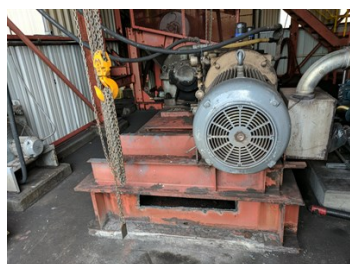
New CST Belt Drives had to be installed and precisely aligned, so that the conveyor belt could return to service. The conveyor belt had to be back in service within 48 hours.

- \* 1- Old CST Drive ,
- \* 2- Anchored Bolts with Belzona 4151 ,
- \* 3- Pouring Belzona 7111 ,
- \* 4- Finalized Application ,

Holes were drilled on the concrete to place the bolts that were going to be used to align and torque the machine. The bolts were anchored using Belzona 4151. A template of the baseplate of the machinery was used as a guideline to install the backer rod on the concrete floor before the actual placement of the machine. The number of chocks and length were all in accordance with the Belzona design specification. Belzona System Leaflet GSS-13 was used to set up and apply Belzona 7111 to precisely align the equipment.

The Belzona solution allowed the mine to replace the drives within their scheduled downtime, the CST drives were aligned and ready to be put back in service in 36 hours. The CST motor drives the main conveyor belt of the plant, so without the conveyor the
