Belzona Seals Wind Turbine Tower Base Against Water Ingress

ID: 7500

Customer Location: Wind Farm, West Texas, USA
Application Date: Summer 2016

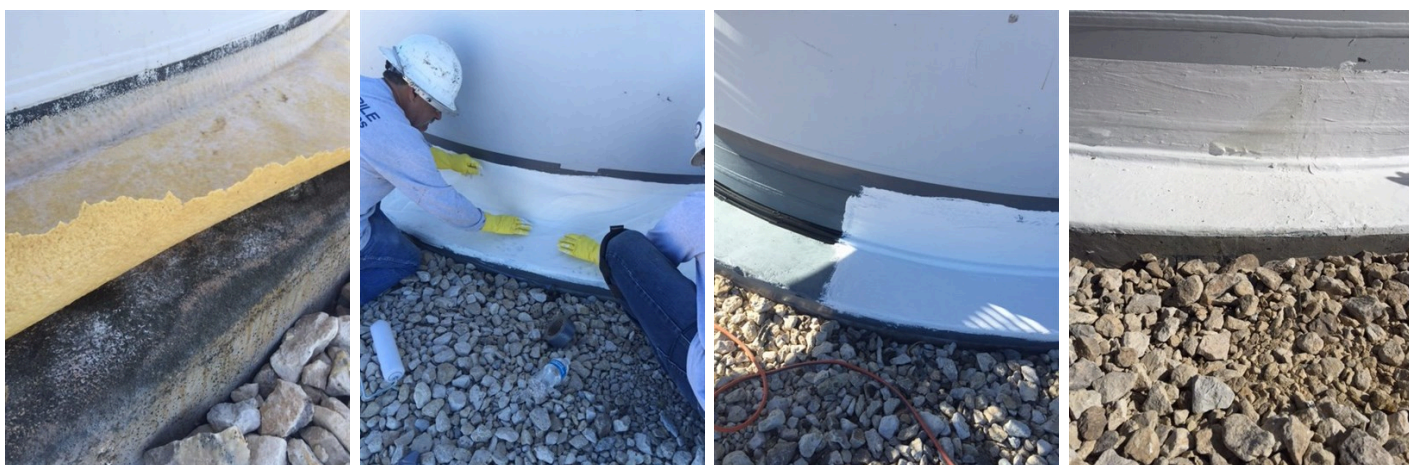
Photograph Descriptions

Rain water and moisture seeps into the ground and into the wind turbine structure through the base around the tower structure. This over time affects the concrete base and propagates cracks and corrosion at the base of the tower. In this case the current coating failed due to UV degradation leading to delamination from the concrete surface.

- * 1. The old coating that failed, yellowing and peeling from the concrete surface. ,
- * 2. The application area being outlined. ,
- * 3. Application of Belzona 3111 underway. ,
- * 4. Application completed and tower base sealed with Belzona 3111. ,

The application was carried out in accordance with a modified version of Belzona System Leaflet WPA-1.

gave the Customer that extra flexibility in that area. Short of sealing with some type of concrete filler they had few options for this problem. Sealing the tank base with Belzona 3111 proved to be a cost-effective solution with minimal downtime and interruption to the operation of the turbine.
