Belzona Coating For Internal Of Closed Drain Drum

ID: 7521

Industry: Chemical & Petrochemical
Application: TCC-Tanks and Chemical Containment Areas
Substrate: Grit Blasted Carbon Steel SA516-70
Products: * Belzona 1391T ,

Customer Location: Refinery, Indonesia
Application Date: July 2017

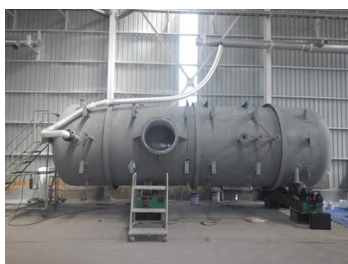
* 1. General view of the vessel during grit blasting 2. 1st coat of Belzona 1391T almost completed 3. high voltage pinhole detection under-way 4. Completed application of Belzona 1391T 2 coat system ,

Application was carried out in accordance with Belzona Know-How System Leaflet TCC-5 and TCC-16. Nozzle inserts were manufactured and bonded into small diameter nozzles to ensure continuity of protection. The coating process was carried out with the vessel on rollers which avoided all overhead application work, and reduced application time considerably.
