Belzona Provides Internal Lining to New Slurry Thickener

ID: 7527

Customer Location: *Chemical Plant, Italy*
Application Date: *September 2017*

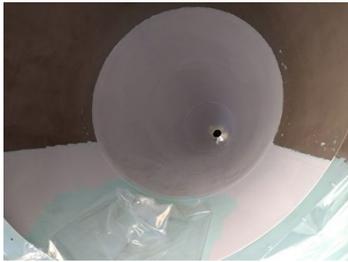
- * 1. Internal view ,
- * 2. DFT Inspection ,
- * 3. Spark test ,
- * 4. Completed application ,

Application carried out in accordance with Belzona System Leaflet SHM-13.
