# BELZONA PROTECTS LEADING EDGE OF WIND TURBINE BLADES

ID: 7537

Industry: Power  
Application: FBC-Fans, Blowers and Compressors

Customer Location: Québec, Canada  
Application Date: Summer 2017

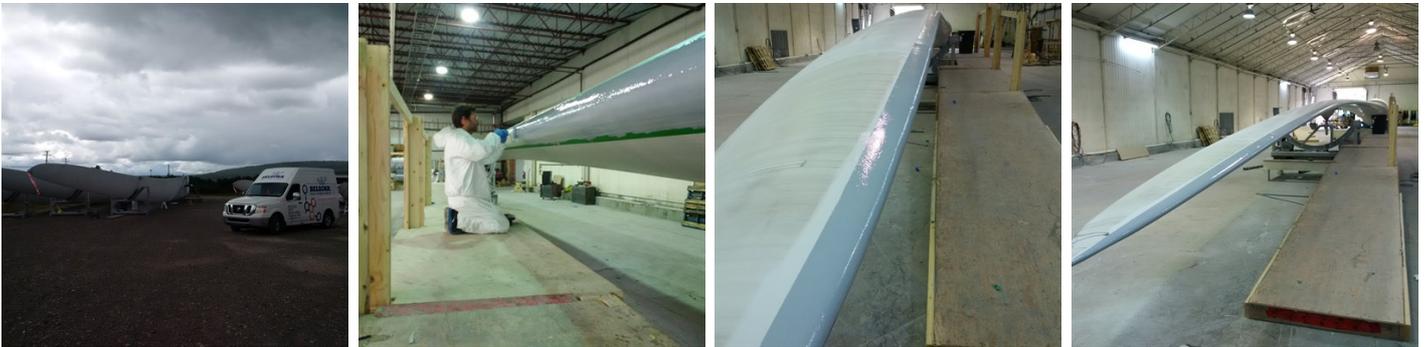
Erosion had started on the leading edge of the blades compromising the performance/energy output and probable life expectancy of the wind turbines. If not properly dealt with, the problem could propagate into a very serious issue in the upcoming years. The Customer had used a different LEP coating in the past and was not happy with the performance and difficulty of application.

- \* 1. Belzona personnel arriving on site to support the application. ,
- \* 2. Belzona 1341 being applied by roller in the outlined and prepared LEP area. ,
- \* 3. & 4. LEP coating complete with Belzona 1341 ,
- \* ,

The application was carried out in accordance with a modified version of Belzona Know-How System Leaflet FBC-1. The blades were brought down and coated on the ground in a large shop area as they were going to do general maintenance on them. The pitting and loss of surface on the leading edge was resurfaced in with a filler product and rebuilt to dimensions. The outlined Leading Edge gel coated surface area was sanded down with a mechanical sander with 80 grit sandpaper and cleaned down with a rag and non-residual solvent cleaner. One coat of Belzona 1341 was applied by roller to an average mil thickness of 12 mils.
