# BELZONA 1212 SEALS LEAKING COPPER GUTTERS AT UNIVERSITY

ID: 7539

Customer Location: College, Cambridge, England  
Application Date: August 2017

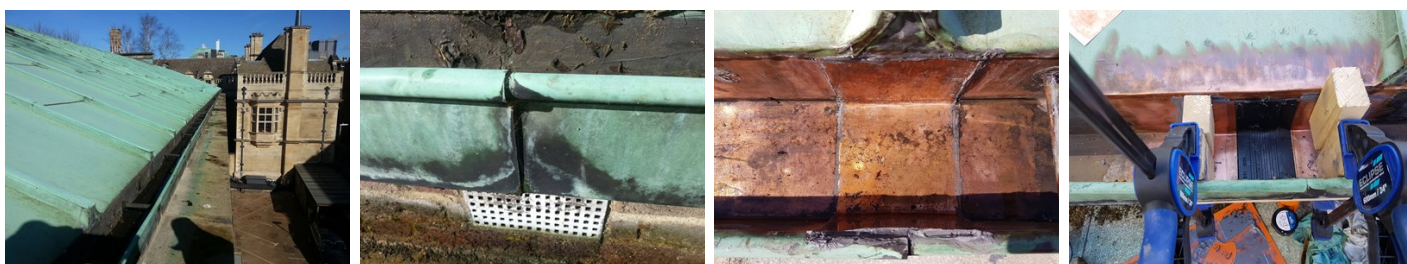
*The 56 joints in the copper gutters had been constantly leaking for almost 40 years causing unsightly staining on the building structure underneath the joints.*

- \* 1.The College Building showing copper gutter and stains on stonework ,
- \* 2.Typical leaking gutter joint ,
- \* 3.Gutter joint cleaned and sealed inside with new copper plate bonded on with Belzona 1212 ,
- \* 4.Flexible system being installed over every 4th joint bonded on with Belzona 1212 ,

Application was carried out in accordance with a modified version of Belzona System Leaflet TCC-1. All loose material in the 56 joint areas was removed to create a really clean and bright copper surface. New 200mm copper strips were cold bonded across the joints using Belzona 1212 to permanently seal the joints. Over every 4th joint a flexible system (supplied by the customer) was bonded using Belzona 1212 in the same way.
