NEW VESSELS COATED WITH BELZONA

ID: 754

Customer Location: Chemical Plant, Basel Ferrara, Italy
Application Date: December 2005

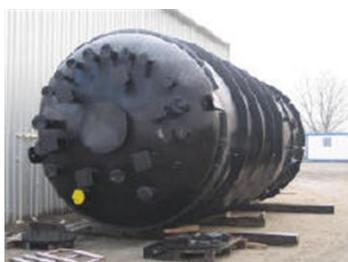
- * View outside of vessel ,
- * Application underway ,
- * Over half of application completed ,
- * Completed application ,
