NEW VESSELS COATED WITH BELZONA

Industry: Chemical & Petrochemical
Application: TCC-Tanks and Chemical Containment Areas
Substrate: Steel
Products: * Belzona® 1391 (Ceramic HT),

Customer Location: Chemical Plant, Basel Ferrara, Italy
Application Date: December 2005

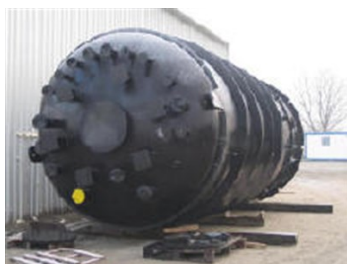
- * View outside of vessel ,
- * Application underway ,
- * Over half of application completed ,
- * Completed application ,

New vessels (90m² each) required lining to resist corrosive media.

Application carried out in accordance with Belzona Know-How System Leaflet TCC-3.
