# BELZONA TANK BASE SEAL TAKES CARE OF THE DETAILS

ID: 7543

**Customer Location:** Petrochemical Plant, UK  
**Application Date:** 2013

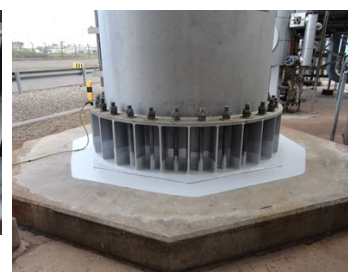
*This hydrogen flare stack had recently been installed on site, but gaps around the “hold down bolts” had resulted in water ingress to the underside of the stack. Several solutions were considered, but with 28 bolts and fins to accommodate, the obvious choice was a Belzona Tank Base Seal solution.*

- \* 1. Initial condition for Flare Stack ,
- \* 2. Close-up of hold down bolt gaps ,
- \* 3. Gaps filled and surfaces primed ,
- \* 4. Tank Base Seal completed in 2013 ,

Application was carried out in accordance with Belzona Know-How System Leaflet GSS-3. Gaps around the bolts were first filled with Belzona 1121, before installing the Belzona Tank Base Seal system.
