# BELZONA TANK BASE SEAL STILL GIVING SUPERB PROTECTION

**Industry:** Chemical & Petrochemical  
**Application:** GSS-Gaskets, Seals and Shims  
**Substrate:** Carbon Steel and Concrete  
**Products:** \* Belzona 3131 (WG Membrane),  
 \* Belzona 6111 (Liquid Anode),  
 \* Belzona 4131 (Magma Screed),

**Customer Location:** Petrochemical Plant, UK  
**Application Date:** 2010

Carbon Steel Fuel Storage Tank

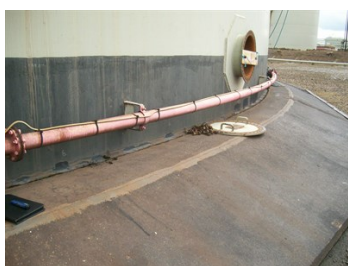
Over the years the bitumen and sand base under this 36m diameter tank had compressed, to such an extent that the annular rim was now at least 10mm below the surrounding concrete plinth. Water was actually being captured at the rim which had dramatically increased the risk of under base corrosion. Various mastics had been tried in the past, but all failed quickly.

- \* 1. Initial condition of tank. ,
- \* 2. Annular rim creating channel for water. ,
- \* 3. Tank Base Seal application in 2010. ,
- \* 4. Tank revisited in 2017 ,

For many years this customer had recognised the long-term benefits of using the Belzona Tank Base Sealing system. After reprofiling the plinth, the Belzona Tank Base Seal was installed around the full diameter, preventing any risk of water ingress to the base. The work was inspected again in 2017 and is still in perfect condition. To date this client has protected over 50 tanks with the Belzona Tank Base Seal solution.
