# Belzona saves a cement silo lid

Customer Location: Concrete products manufacturer,  
Bedfordshire, UK

Application: TCC-Tanks and Chemical Containment  
Areas

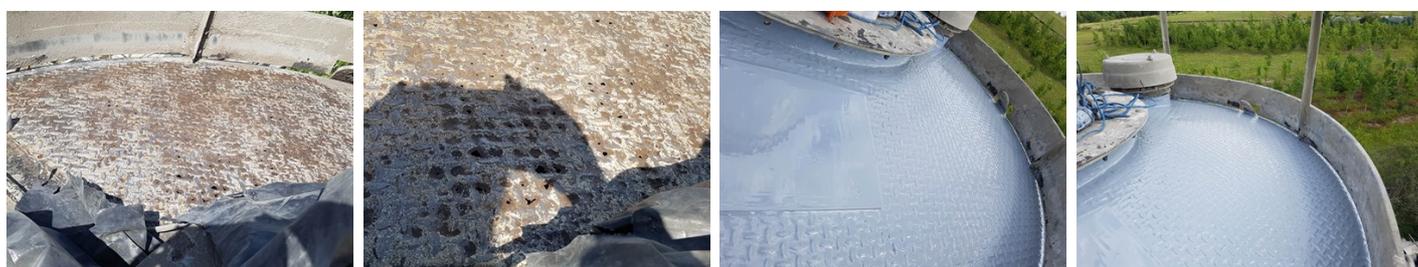
Any moisture ingress will ruin the stored materials. The customer had noticed problems and after inspecting found that the lid was severely corroded and was letting in rainwater. The silo is 11 metres high, to replace the lid would be logistically very difficult and incredibly expensive.

- \* 1. The silo lid at the start of the repairs ,
- \* 2. A closer look at the damage ,
- \* 3. The lid repaired with Belzona 1111 plate bonding techniques ,
- \* 4. The finished lid after application of Belzona 5811 ,

Application was carried out in accordance with Belzona System Leaflets TCC-1 and TCC-5. Steel plates were bonded to the lid using B1111 where required to repair the holed areas before applying two coats of Belzona 5811 to provide overall corrosion protection.
