BELZONA PROTECTS THE SURFACE OF MAIN WATER-PUMP INLET MANIFOLD

ID: 7556

Customer Location: *Mining Company, Norway*
Application Date: *September - October, 2017*

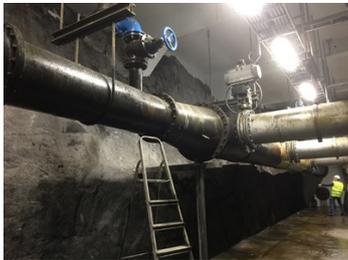
Severe corrosion on these pipes externals had developed over 50 years, several unsuccessful attempts to protect the pipe had been started and ended without fully protecting the surface over the last 10 years. Humidity of 100%, constant running water from the surface and no possibility to gritblast meant conditions were not ideal for a coating application.

- * 1. Overview of wet and condensed pipe manifold. ,
- * 2. Surface preparation and first coat application ongoing. ,
- * 3. First coat applied. ,
- * 4. Final coat applied and cured. Constant running water from the surface can be seen. ,

Application was carried out in accordance with a modified version of Belzona Know-How System Leaflet CEP-4. Manual surface preparation was carried out using a combination of different tools. Belzona 1212 was used to fill deep pitting in the surface. Then, Belzona 5831 was applied for corrosion protection.
