Belzona Protects a New Condenser

Industry: General Industry
Application: HEX-Heat Exchangers
Substrate: Carbon Steel
Products: * Belzona 5892 ,

Customer Location: Manufacturer, Czech Republic
Application Date: 2016

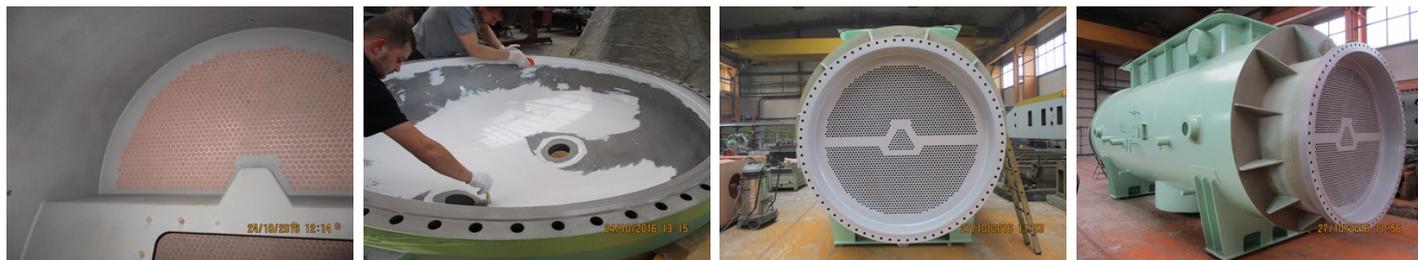
Photograph Descriptions

- * 1. Condenser after grit blasting. ,
- * 2. Applying Belzona 5892 on the condenser cover. ,
- * 3. Completed application. ,
- * 4. Condenser after application. ,

Application was carried out in accordance with Belzona System Leaflet HEX-03. After preparing the surface by grit blasting, a stripe coat was applied on complex areas such as edges, welds etc. Then 2 coats of Belzona 5892 were applied.
