Belzona Repairs and Protects Pump Volute in Nuclear Plant

Customer Location: Nuclear Power Station, France

Application: CEP-Centrifugal Pumps

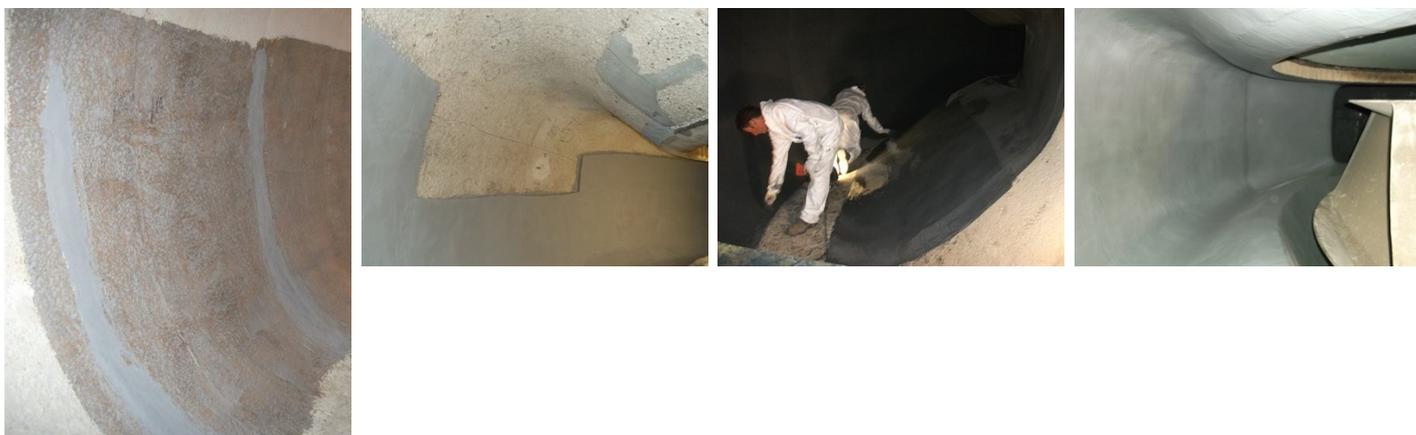
Photograph Descriptions

After several years in service, the concrete started to show signs of erosion, showing regular wear and cracking. Repairs were needed, otherwise this wear would have accelerated and risked causing damage to heat exchangers.

- * 1. Surface preparation. ,
- * 2. Application of Belzona 4111 in progress to rebuild the concrete wall. ,
- * 3. Final coat of Belzona 1321. ,
- * 4. Finished application. ,

The application was carried out in accordance with Belzona Know-How System Leaflet CEP-03. Belzona 4111 and Belzona 1321 were used to repair and protect the walls.

There was no real alternative other than rebuilding with concrete, leaving it prone to the same damage. The repair of the two volutes was done in full respect of the scheduled shutdown of the plant, so without any consequences for the production activity. The pump volute is inspected annually, this was done most recently in 2017 and still found to be in an excellent condition.
