Machine for cellulose production levelling

ID: 7621

Industry: *Pulp & Paper*
Application: *GSS-Gaskets, Seals and Shims*
Substrate: *Concrete*
Products: *Belzona 5811 (Immersion Grade)*

Customer Location: *Cellulose production plant, Slovakia*
Application Date: *July 2016*

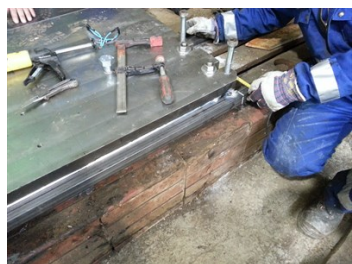
Bases of the machines have to be seated on the correct place

Bases of the machines have to be seated on the correct place, then Belzona 5811 was injected to fix the bases.

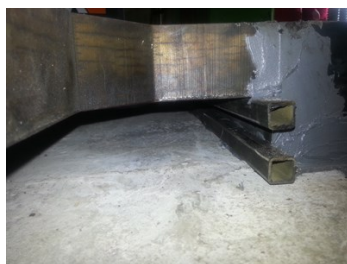
Every possible leakage had to be close

Injection

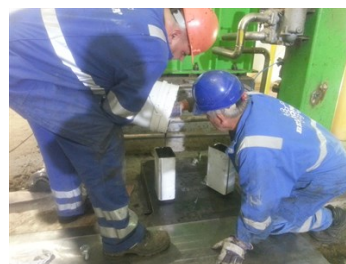
Ready to work
