Belzona Vessel Lining for New Separators with Spray and Nozzle Insert Application

ID: 7627

Customer Location: Vessel Manufacturer, Thailand
Application Date: July - October 2017

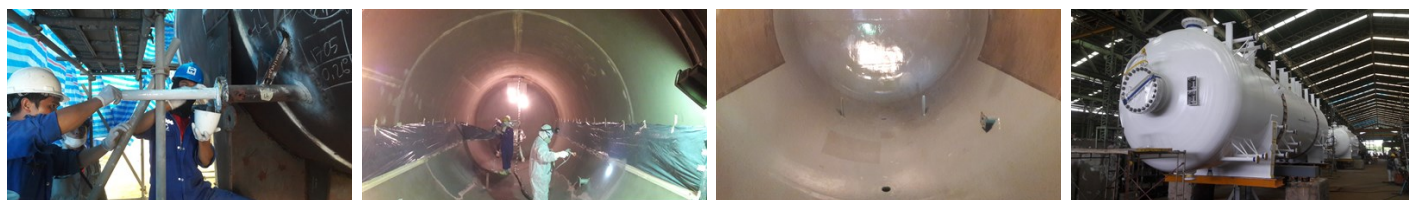
Photograph Descriptions

- * 1. Nozzle Insert Application. ,
- * 2. Spray Application of Belzona 1391S. ,
- * 3. Completed application. ,
- * 4. Overview of Finalised Vessels with External Paints on them. ,

Application was carried out in accordance with Belzona Know-How System Leaflets TCC-5 for protecting and rebuilding steelwork, and TCC-16b for protecting the small bore nozzles. The linings were applied to the bottom half and the inlet end dome of each vessel. Prior to the spray application of Belzona 1391S, stripe coat and nozzle insert were conducted with Belzona 1391T. The inserted sleeves were pre-fabricated with Belzona 1511.
