# NEW TRANE CHILLER PROTECTED WITH BELZONA

ID: 7644

**Application:** HEX-Heat Exchangers

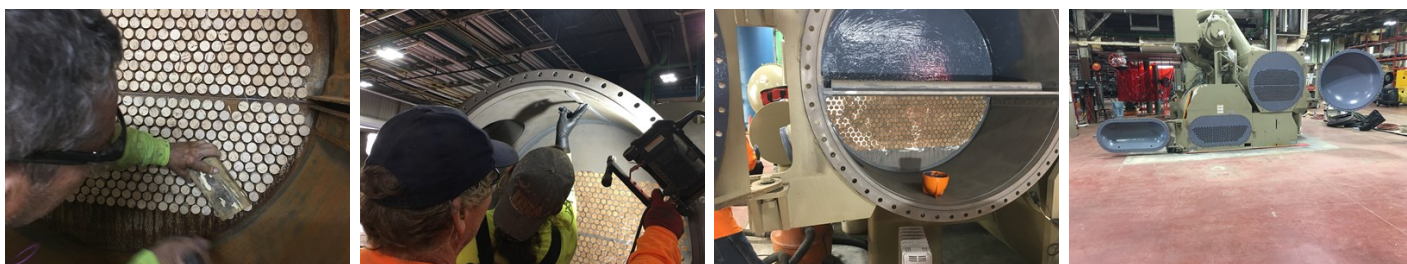
## Photograph Descriptions

- \* 1. Corks were added before blasting. Then the unit was blasted. ,
- \* 2. More corks were added then ground down flush since the copper tubes were flush with the sheet. All seams were sealed with 1121. ,
- \* 3. Care was taken to seal the ends of the inserts so no water could enter during operation and cause rusting from the inside out. ,
- \* 4. Both ends of the chiller and the water boxes were coated and the corks were blown out and the tubes cleaned out to turn over to the owner. ,

The application was carried out in accordance with Belzona Know-How System Leaflets HEX-1, HEX-2, and HEX-3. Belzona 1121 was used to seal all the seams before coating, Belzona 1321 was applied in two coats after Belzona 1121 was cured. The product was applied by hand. Corks were inserted before blasting then again before coating to protect the copper tubes. The water boxes were also coated.
