BELZONA SUPERWRAP II SEALS THROUGH CRACKS ON A 90 DEGREE FLANGE FOR A CHILLER PUMP

ID: 7654

Industry: Fluid Flow
Application: CEP-Centrifugal Pumps
Substrate: Cast Iron
Products: * Belzona 1111 (Super Metal) ,
* Belzona Superwrap II ,

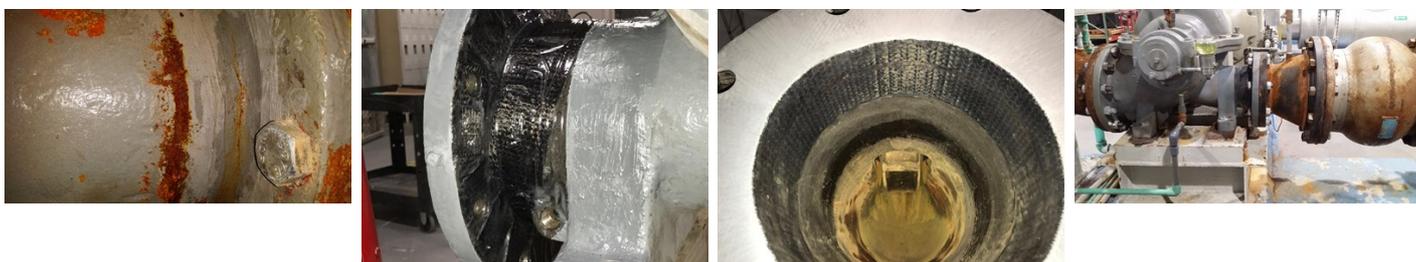
Photograph Descriptions

The Customer attempted to repair the cracks. However, leaks still existed after the pump was reinstalled onto the chiller return line and tested. The new solution of Belzona Superwrap II was suggested for the 90 degree flange.

- * 1. Customer's attempted repair. ,
- * 2. Superwrap II application on the outside of the flange. ,
- * 3. Superwrap II application on the inside of the flange. ,
- * 4. Pump reinstalled and working after 4 months of operation nonstop and still working with no leaks. ,

The inside bend of a flange leaking return line chiller water at a theme park.

Surface was prepared with abrasive blast clean following the Manufacturer's Instructions for Use. The ends of the through cracks were drilled and Belzona 1111 was applied into the inside of the cracks. Once Belzona 1111 set up and still within the overcoat time, 4 wraps of Belzona SuperWrap II were applied on the inside of the 90 degree bend of the flange and the outside to re-enforce it for strength. The application was carried out in accordance with a modified version of CEP-6 Belzona System Leaflet.
