# BELZONA REPAIRS AND PROTECTS AGAINST CHEMICAL ATTACK

Customer Location: *Aviation repair facility, Florida, USA*

Chemicals storage room spill collection trough.

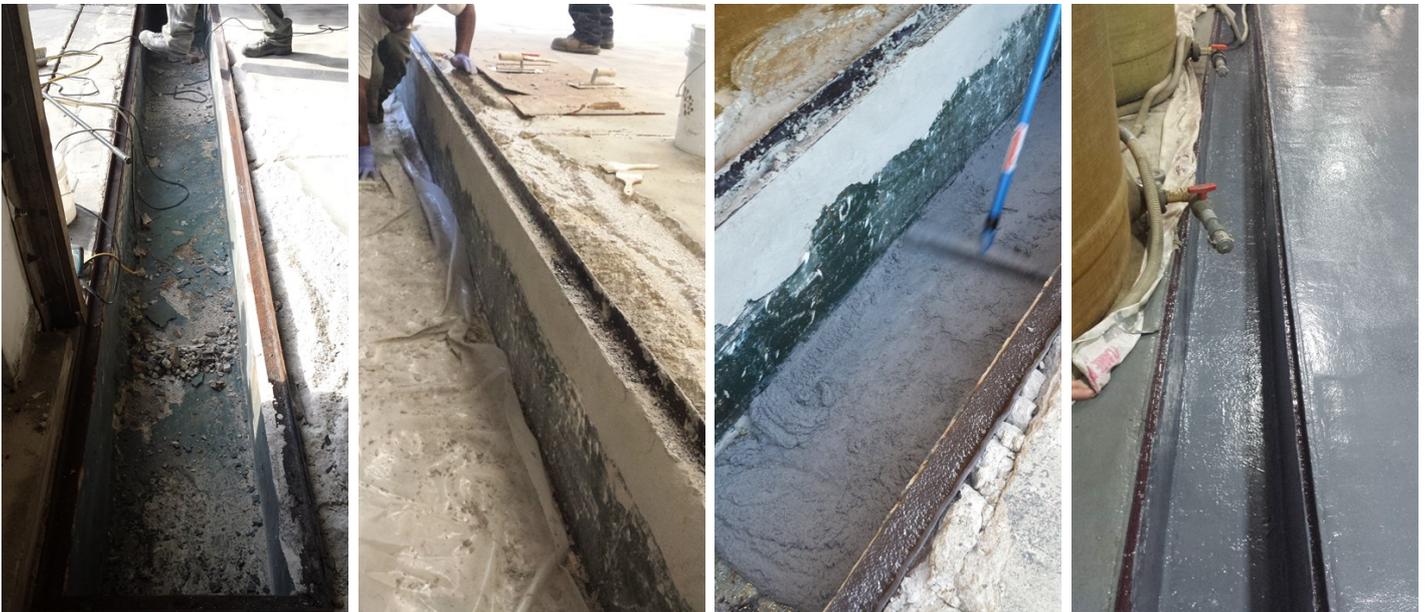
*Sulfuric acid and other chemicals were collecting through the years into the trough and severely compromising the integrity of the structure.*

- \* 1. Trough condition before the repair ,
- \* 2. Surface preparation and walls rebuilt with Belzona 4141 ,
- \* 3. Rebuilding and leveling bottom of trough with mixture of Belzona 4151 and Belzona 4131 ,
- \* 4. Completed application after two coats of Belzona 4311 ,

Application was carried out in accordance with a modified version of Belzona System Leaflets TCC-09, TCC-15 and WPA-04. Damaged concrete was rebuilt and leveled with a slurry mixture of Belzona 4111 and Belzona 4151. Vertical damage was repaired with Belzona 4141. The structure was protected with two coats of Belzona 4311.
