Meat Processing Plant In Need of Belzona On Cooling Towers

ID: 7669

Industry: Food & Drink
Application: TCC-Tanks and Chemical Containment Areas
Substrate: Carbon Steel
Products: * Belzona 5811 ,
* Belzona 5111 ,
* Belzona 3921 ,
* Belzona 3111 ,

Customer Location: Florida, USA
Application Date: December 4-9, 2017

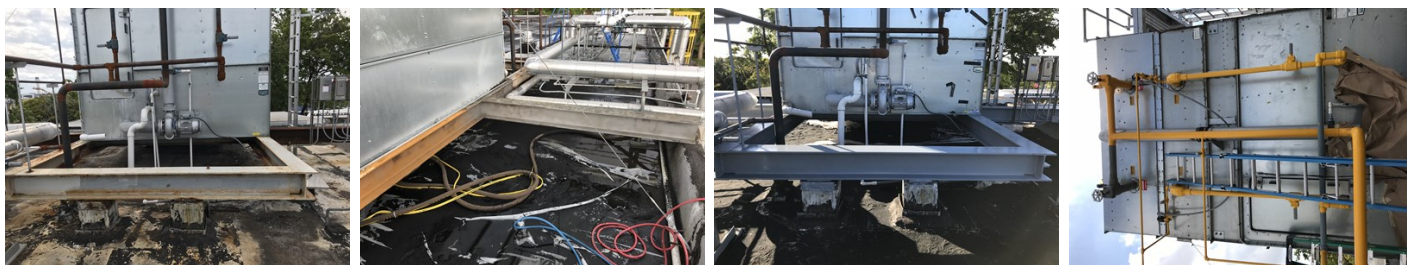
Photograph Descriptions

- * 1. Framework and piping before surface preparation. ,
- * 2. Ongoing surface preparation using grit-blasting. ,
- * 3. Framework after application of Belzona 5811 and Belzona 5111. ,
- * 4. Piping after application of Belzona 3921 and Belzona 5111. ,

The customer had acquired and installed a brand new cooling tower on an existing corroded framework. Piping system was also corroded.

Application carried out in accordance to a modified version of TCC-05. Framework was grit-blasted to NACE 2 Standard. One coat of Belzona 5811 and two coats Belzona 5111 were applied. Some sections of the framework were inaccessible for coating and -in lieu- the access point was sealed with Belzona 3111. Piping system was prepared using power tools. One coat of Belzona 3921 and two coats of Belzona 5111 were applied.
