Belzona SuperWrap II Novel Nuclear Insert

Pump drain and suction pipe within a nuclear power station.

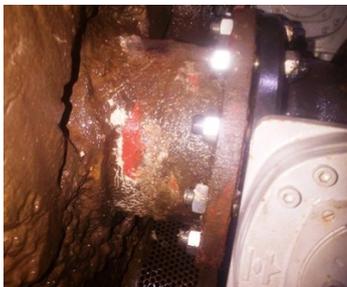
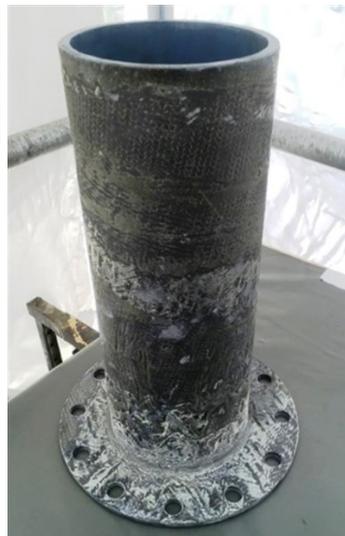
Photograph Descriptions

Damp conditions within the area have caused the breakdown of concrete surroundings and corrosion of the pipework, leading to significant loss of wall thickness. The asset owner required the structural integrity of the pipe to be reinstated. The Belzona SuperWrap II system could not be applied externally on the pipework, as it was housed within the concrete foundations, leading to the unique and novel use of the Belzona SuperWrap II system to manufacture an insert.

- * 1. Extensive damage of the pipework and concrete within the pump drain. ,
- * 2. Manufacturing the Belzona SuperWrap II insert ,
- * 3. Completed Belzona SuperWrap II insert ,
- * 4. Final application coated with Belzona 1321 ,

Application was carried out in accordance with a modified version of Belzona System Leaflets TCC-16a and TCC-16b. The pipe insert was manufactured using the Belzona SuperWrap II system, then bonded in using Belzona 1161 before being coated using Belzona 1321 for added abrasion resistance.
