# OLD PUMPS REPAIRED, PROTECTED AND IMPROVED WITH BELZONA

Industry: Marine  
Application: CEP-Centrifugal Pumps  
Substrate: Cast Iron  
Products: \* Belzona 1121 ,  
\* Belzona 1341 ,

Customer Location: Dry Dock Facility, BC, Canada  
Application Date: August 2017

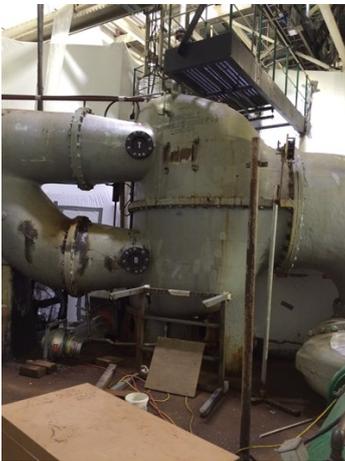
- \* 1. 30 ft high pump. ,
- \* 2. Showing damage from erosion-corrosion. ,
- \* 3. Application of Belzona 1341 Blue in progress. ,
- \* 4. Complete application. ,

Pumps housing building at a Canadian historic site. 30 ft high pumps.

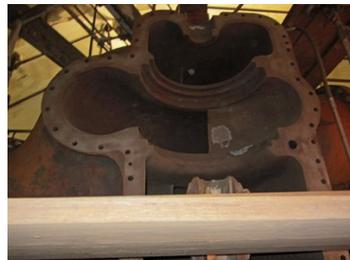
The pumps were damaged by erosion-corrosion due to the salt content in the water they were pumping. Holes had developed in some of the cast iron casings and stuffing boxes also needed major rebuilding. Although the pumps were old, replacing them was not possible.

The application was carried out in accordance with modified versions of Belzona Know-How System Leaflets CEP-1 and CEP-3. Belzona 1121 was used to rebuild and repair the eroded surfaces. Belzona 1341 was used to improve the pumps performance. Due to the large size of the pumps and related inlets and outlets, it was decided to blast in stages and then protect with Belzona 1341. This was followed by a skim coat of Belzona 1341/1121 mixture to fill in most of the lower depressions. The remaining voids were filled with Belzona 1121. The units received a final brush blast before 2 successive coats of Belzona 1341 grey and blue were
