# Belzona Saves Silo Lid

**Industry:** Buildings & Structures  
**Application:** TCC-Tanks and Chemical Containment Areas  
**Substrate:** Steel  
**Products:** \* Belzona 1111 (Supermetal) Belzona 5811 (Immersion Grade),

**Customer Location:** Bedfordshire, UK  
**Application Date:** August 2017

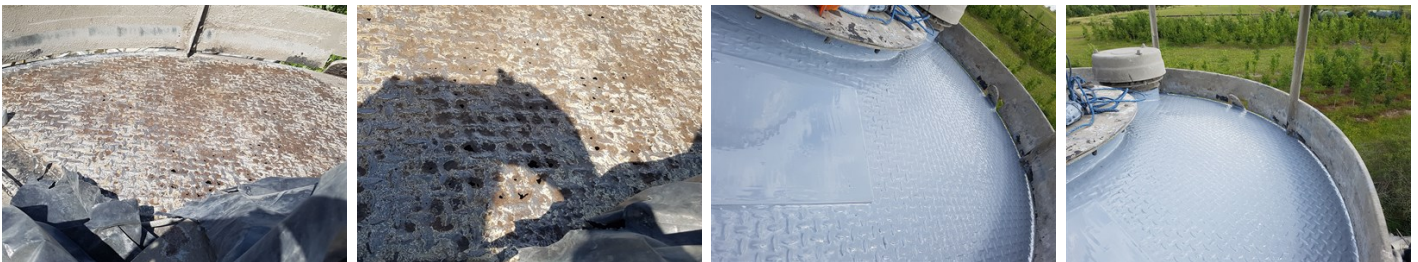
The customer had noticed problems with their cement storage silo and after inspecting found that the lid was severely corroded and was letting in rainwater. The silo is 11 metres high, to replace the lid would be logistically very difficult and incredibly expensive.

\* 1. The silo lid at the start of the repairs 2. A closer look at the damage 3. The lid repaired with B1111 plate bonding techniques 4. The finished lid ,

The lid was cleaned thoroughly using a bristle blaster as grit blasting was not possible at the height required due to logistical and environmental factors. Steel plates were then bonded to the lid using B1111 where required to repair the holed areas using an adapted version of Belzona System Leaflet TCC-3 Once the plates were bonded into place and the B1111 had cured, two coats of B5811 were applied to the silo lid.
