Belzona repair and coating internal surface of rotor can of preheat unit and repair shaft of cooker unit

ID: 7709

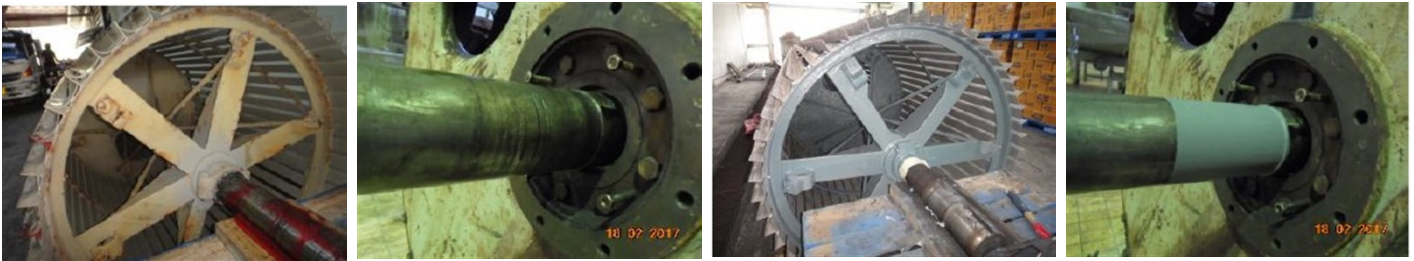
The damage area cause by erosion and corrosion

- * 1. The rotor damage area cause by erosion and corrosion ,
- * 2. Damage shaft surface at cooker unit ,
- * 3. Application complete with Belzona 1391S for rotor ,
- * 4. Application complete with Belzona 1111 for shaft ,

1. Carbon steel surface will be prepare by copper slug to give a minimum depth at 75 microns and surface cleanliness by Sa 2.5
2. Clean and brush away any loose contaminate, cleaning with vacuum cleaner machine then cleaning the surface with MEK.
3. Apply two coats system of Belzona 1391S Ceramic HT at dry film thickness 500 microns.

1. Surface preparation with hand grinding machine.
2. Repair corrode area with Belzona 1111 Supermetal.
