# Belzona 3211 Used for Fuel Pipeline Insulation inside Engine Room

Industry: *Marine*  
Application: *TCC-Tanks and Chemical Containment Areas*  
Substrate: *Stainless-steel*  
Products: *Belzona 3211 (Lagseal),*

Customer Location: *Croatia, Marine*  
Application Date: *January 2003*

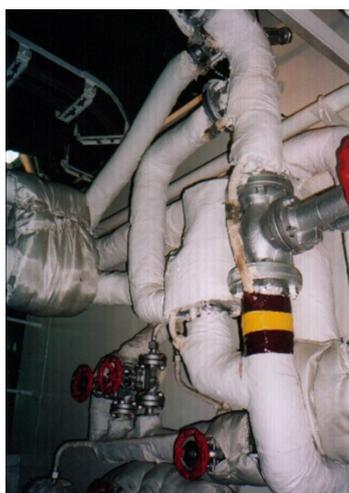
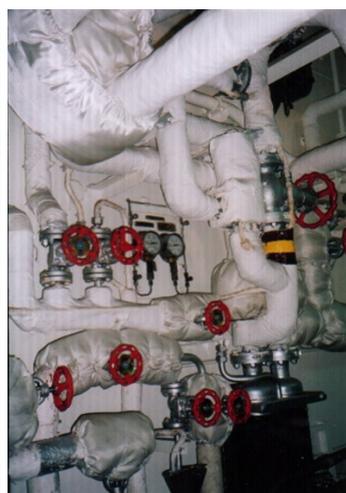
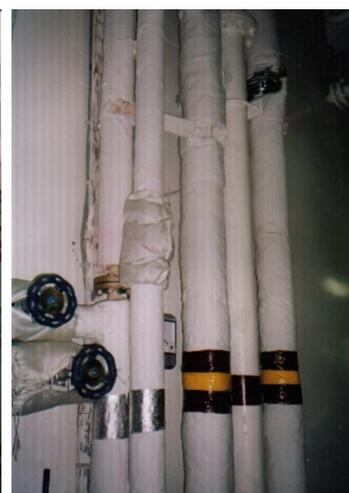
*Insulation on various complex geometries required waterproofing. Other solutions considered for this application were rejected due to Health & Safety concerns.*

The application took place in Rijeka shipyard, Croatia, on two newly built vessels - a Whitefin Shipping Chemical Tanker and a Gibraltar Chemical Tanker.

The application was carried out in accordance with Belzona Know-How System Leaflet TCC-4.

Belzona 3211 is weather and fire resistant, and conforms to the requirements for 'Class A' in accordance with 'ASTM E84'. It would not add to a fire and also would not create poisonous gases in case there was ever a fire.
