Belzona 3211 Used for Fuel Pipeline Insulation inside Engine Room

ID: 7728

Customer Location: Croatia, Marine
Application Date: January 2003

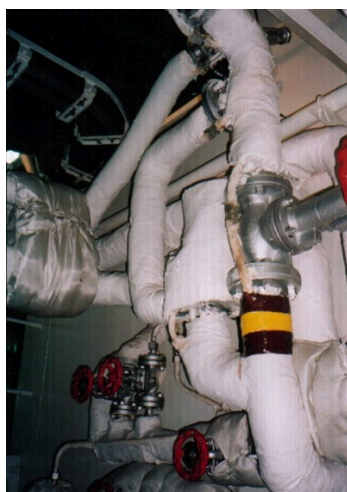
- * 1. View of the vessel ,
- * 2. Application complete ,
- * 3. Application complete ,
- * 4. Application complete ,

The application was carried out in accordance with Belzona Know-How System Leaflet TCC-4.
