# Protection of New Vertical Pump for Potable Water Service

ID: 7733

Application: CEP-Centrifugal Pumps

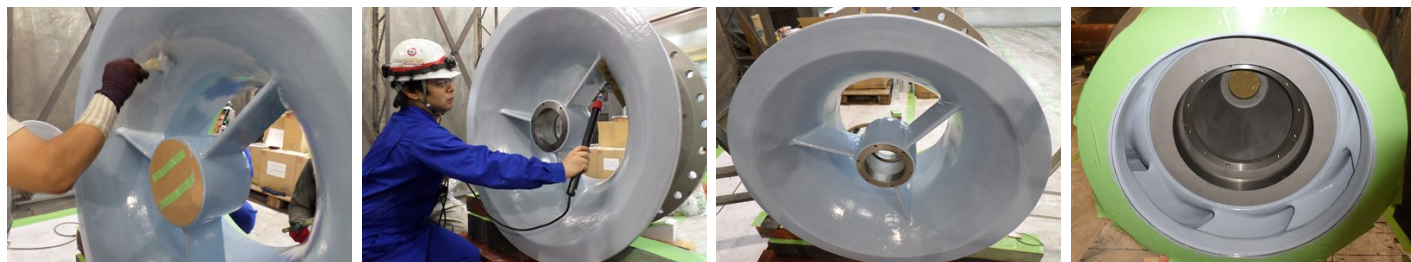
- \* 1. Application of 2nd coat on the Suction Bell ,
- \* 2. Spark testing the Suction Bell ,
- \* 3. Suction Bell completed ,
- \* 4. Discharge Bowl completed ,

Application was carried out in accordance with Belzona Know-How System Leaflet CEP-3, at the fabrication site of pump manufacturer in Japan. A suction bell and a discharge bowl were blasted and coated with NSF approved Belzona® 1341 internally. Blow holes found were filled with Belzona® 1111 to achieve smooth surfaces prior to the final coat of Belzona® 1341.
