Belzona Cuts Down a Concrete Shimming Application Time from 45 to 7 days

Customer Location: *Paper Mill, Brazil*

Application:

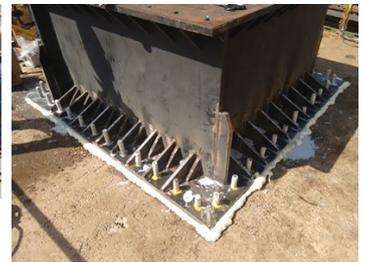
Due to constant movement and vibration created between the skid and the concrete foundation, the heads of the bolts holding the base down started to break off.

- * View of the Crane ,
- * Concrete foundation before ,
- * Application in progress including new anchor holes being drilled ,
- * Completed application ,

First, 48 new holes were drilled to install newly fabricated bolts. Then the skid was positioned over the concrete base, secured and aligned with 4 metal bars in 4 points around the perimeter of the skid, and positioned on top of the concrete base. Belzona 4111 and Belzona 4151 were then mixed and injected into each of the holes. Anchor bolts were inserted, and excess of product was used to fill the annular space under the equipment.
