Belzona 3111 to Waterproof a Stunning New Build Development

Industry: Buildings & Structures
Application: RPA-Roof Problem Areas
Substrate: Concrete
Products: * Belzona 3111 (Flexible Membrane) ,

Customer Location: Paris, France
Application Date: July 2018

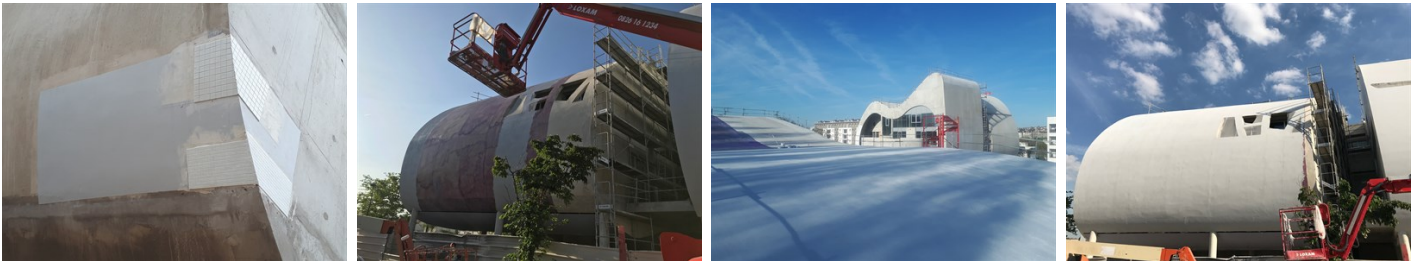
Photograph Descriptions

- * 1 - A close up of the Belzona 3111 with the tiles bonded on top ,
- * 2 to 4 - Application in progress ,

Belzona 3111 was rolled onto the roof to completely encapsulate it. Then it was overcoated with an adhesive to bond the tiles.
