BELZONA 5122 CLADDING PROTECTS A BRICK AND MASONRY STRUCTURE AT A UNIVERSITY BASEBALL STADIUM

ID: 7759

Industry: *Buildings & Structures*
Application: *WPA-Wall Problem Areas*
Substrate: *Concrete, Brick and Rough Cut Cinder Block*
Products: ** Belzona 5122 (Clear Cladding) ,*

Customer Location: *Oregon, USA*
Application Date: *September, 2018*

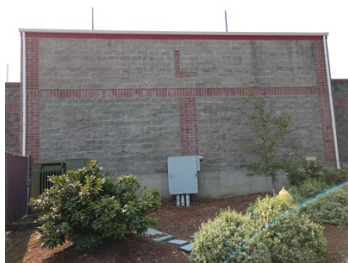
The structure needed to be protected from water ingress and water penetration, as the water penetrating inside was corroding metal components of these electronic systems, threatening their operation. The University had used Belzona 5122 on other buildings in the past and had confidence that Belzona could fix the problem while retaining the original aesthetics of the stadium.

- * The wall needing protection from water penetration ,
- * Corrosion had begun to degrade the internals and threatened damage to electronics ,
- * Application of Belzona 5122 ,
- * Stadium protected and ready for the games ,
