BELZONA ELASTOMER SEALS CHAIN PLATE CASING ON NEW YACHT

ID: 776

Chain plate casings on a new luxury yacht under construction

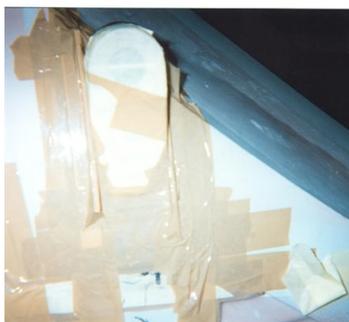
- * Tape used to contain Belzona during the pouring operation ,
- * The chain plate pocket sealed with Belzona® 2131 ,
- * Close up showing neat Belzona seal created ,

Application was carried out in accordance with Belzona Know-How System Leaflet GSS-4. As the application was partly vertical, tape was used to create a dam to enable the Belzona Elastomer to be poured into place.
