# BELZONA ELASTOMER SEALS CHAIN PLATE CASING ON NEW YACHT

ID: 776

Chain plate casings on a new luxury yacht under construction

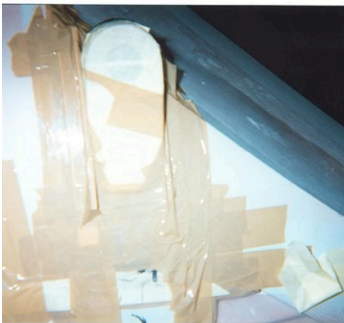
*At late stage in construction it was realized that the design of the chain plate location into the superstructure would allow water ingress.*

- \* Tape used to contain Belzona during the pouring operation ,
- \* The chain plate pocket sealed with Belzona® 2131 ,
- \* Close up showing neat Belzona seal created ,

Application was carried out in accordance with Belzona Know-How System Leaflet GSS-4. As the application was partly vertical, tape was used to create a dam to enable the Belzona Elastomer to be poured into place.

It was not possible to change the design of the chain plate location into the superstructure so the Belzona solution was the only option available to ensure this location remained watertight.
