# Belzona protects cooling tower basins for a sugar refinery

**Industry:** Sugar  
**Application:** TCC-Tanks and Chemical Containment Areas  
**Substrate:** Concrete  
**Products:** \* Belzona 4111 (Magma-Quartz) Belzona 4151 (Magma-Quartz Resin) Belzona 5811 (Immersion Grade),

**Customer Location:** France  
**Application Date:** July 2018

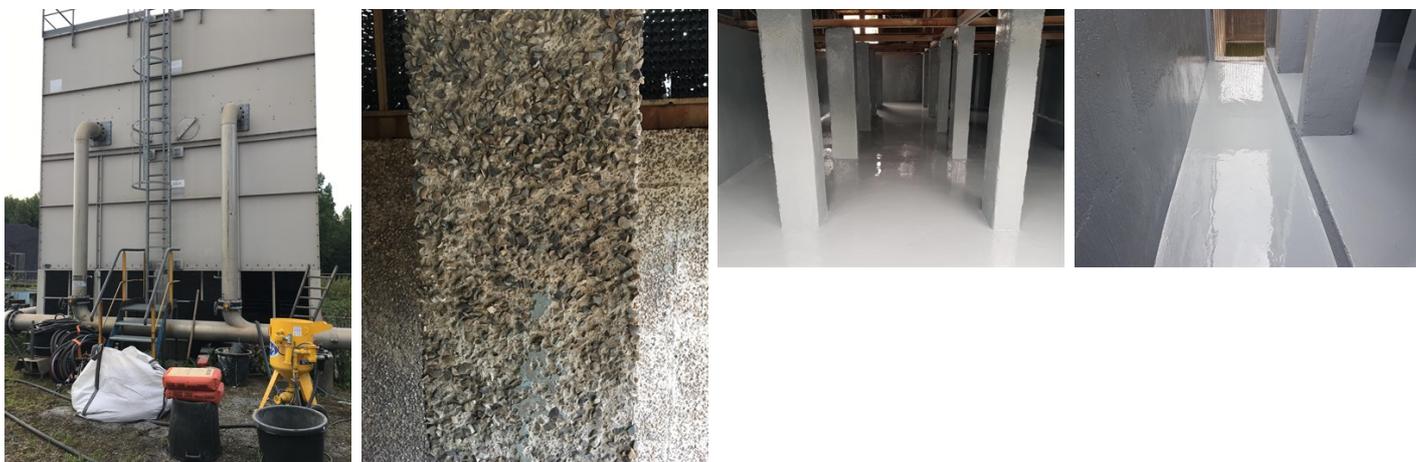
After an audit, the company was asked to check that their cooling basins were in good shape. They realised that a few of them needed to be fixed. The concrete was disintegrated and the resin (not a Belzona resin) that had been applied a few years ago was not efficient anymore and this required removing and replacing.

\* 1- Outside view of the tank 2- Blasted pole inside the basin 3- Final application 4- Zoom on the final application ,

The cooling basins used in this refinery were attacked by chemicals: bleach and anti-corrosion agents which are usual additives for industrial cooling waters.

The concrete was prepared by sand blasting, Belzona 4111 with Belzona 4151 was used to repair and resurface the cracks then the basins were coated with 5811 for chemical protection in accordance with Belzona Know How system leaflet TCC-9 + TCC-15.
