Belzona's Preventive Protection for a Geothermal Plant Cyclone

ID: 7773

Preventive application on a cyclone in a geothermal plant.

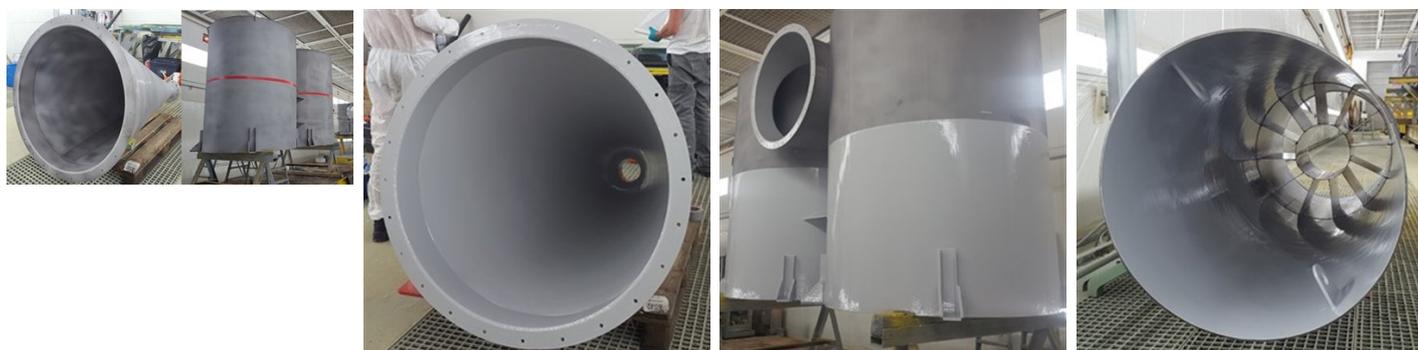
Photograph Descriptions

- * Equipment overview after grit blasting. ,
- * Protection with Belzona 1523. ,
- * Protection with Belzona 5892. ,
- * Protection with Belzona 5892. ,

The steel was grit blasted first, then all the surfaces in contact with brine and the inside of the exhausts were coated with Belzona 5892. Belzona 1523 was then used for the protection of the parts exposed to important erosion and high temperatures.
