# DATA CENTER'S ENGINEERING ROOM WATERPROOFED WITH BELZONA

ID: 7788

**Customer Location:** Virginia, USA  
**Application Date:** October 2011

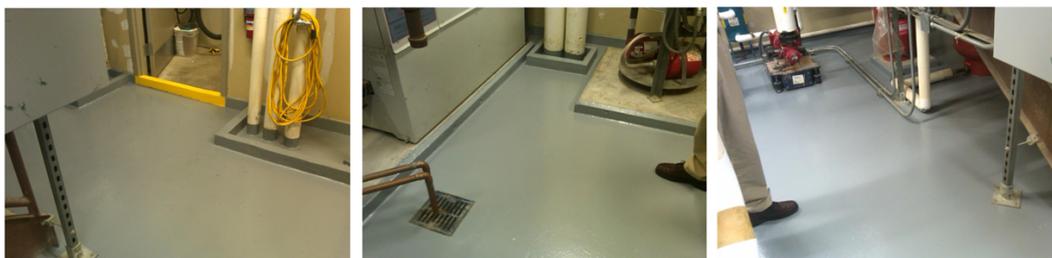
\* Threshold built with Belzona 4131 and made "safety" visible with Belzona 4411 Curbs around the piping built with Belzona 4131. The floor is coated with Belzona 5231 Application is completed ,

Belzona materials were used to install new curbs and thresholds and to provide a protective sealant to the flooring. Belzona 3121 was used to seal the areas between piping and the floor. The threshold at the door and curbs around the piping were built with Belzona 4131. To avoid a trip hazard and to ensure safety the thresholds were coated with Belzona 4411 Yellow. Then, the entire floor was coated with Belzona 5231 for chemical and water protection as well as to provide a non-slip and easy-to-clean finish. No more leaks jeopardizing the critical facility below.
