Underground Seawater Pipeline SuperWrapped with Belzona

ID: 7796

Customer Location: *Sicily, Italy*
Application Date: *August 2018*

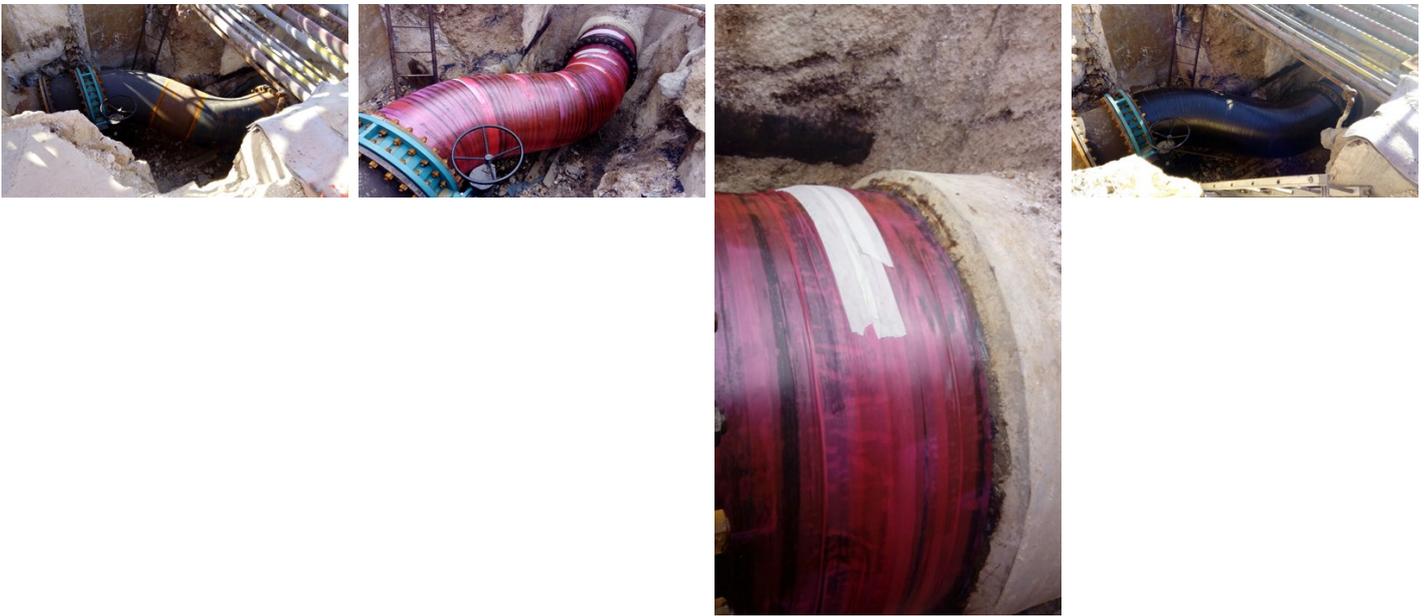
Photograph Descriptions

Internal corrosion of pipeline and initial stages of weld degradation has been observed.

- * Pipeline before repairs ,
- * Belzona SuperWrap II system applied and consolidated ,
- * Interface with concrete ,
- * Belzona release film removed ,

Underground section of a seawater pipeline as part of a cooling system for a refinery.

The application was carried out in accordance with a modified version of Belzona Know-How System Leaflet VPF-11.

The customer wanted to reinforce and extend the life of the pipeline. As the pipeline is critical to the operation of some of the processes within the refinery, they did not want to shut down the pipeline. Hence, Belzona was requested to offer an online repair. Additionally, due to the pipeline being underground in a difficult to access area, grit blasting was not possible. The qualification of Belzona SuperWrap II onto power tool cleaned surfaces was essential to win the project. The local Belzona Distributor, BS Srl, were crucially able to offer the full compliant pipe wrap service from design through to application, differentiating the Belzona solution from the competition.
