# Belzona Seals Process Tower Roof

ID: 7801

Customer Location: *Fertiliser Plant, France*  
Application Date: *October 2018*

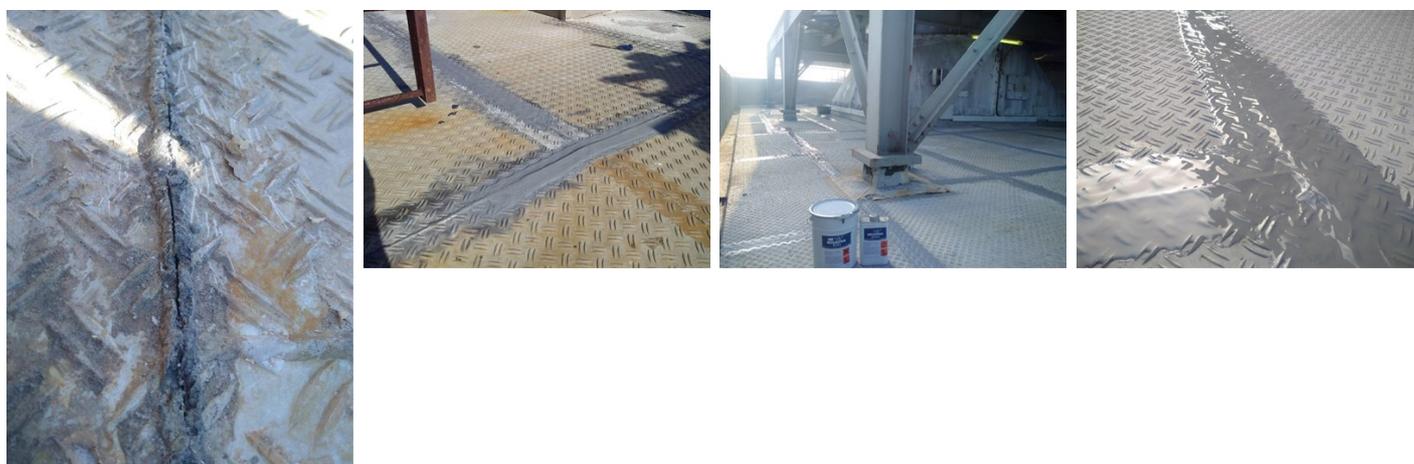
*The roof of a process tower in this fertiliser plant was leaking due to the chemicals that were attacking the welds. Infiltration of water was becoming problematic for the production and the roof had to be fixed.*

- \* Before application ,
- \* Sealing step with paste grades ,
- \* Final application ,
- \* Sealing close up ,

Aluminium roof of a process tower

The previous repairs were removed and Belzona 1111, 1161, 1212 and 9341 (reinforcement sheet) were used to seal the gaps. Then two coats of Belzona 3121 were applied on top of the repairs to seal in accordance with Belzona KNow-How System Leaflet RPA-1.
