# BELZONA COLD PLATE BONDING SAVES A STORAGE TANK'S ROOF

ID: 7810

Roof top of an oil storage tank in a port authority facility.

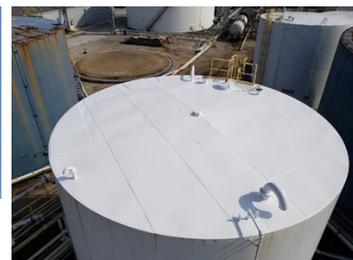
*Roof top near edges exhibited thinned metal and through holes.*

- \* Tank roof top exhibiting damaged areas ,
- \* Thinned and holed areas near the edge of the tank roof ,
- \* Job discussion with the Contractors ,
- \* Completed plate bonding ,

Plates could not be welded to the remaining substrate. Cold plate bonding technique was chosen to cover roof top holed areas. The Customer's contractor removed large thinned sections of the roof top and prepped the remaining substrate by a hand-held grinder. New steel plates had been pre-cut and abrasive blasted to a near white metal finish with a 3 mill angular profile. Belzona 1161 was mixed - the roof top surface had been wetted out with a small 2" cut chip brush. At the same time the remaining mixed material was applied to the bottom of the new steel plates creating a build-up in the center of the plates to allow Belzona 1161 to spread out evenly filling all the voids.

Provided the scale of the damage and inability to use welding, Belzona cold plate bonding was the only solution possible. Belzona 1161 was selected due to its surface-tolerant abilities as using abrasive blasting to the tank's roof was not an option. The application was completed with zero hot work thus making it a safe application for the Contractors and facility.
