# Belzona Rebuilds and Protects a Clarifier

ID: 7816

Industry: Water / Wastewater  
Application: TCC-Tanks and Chemical Containment Areas

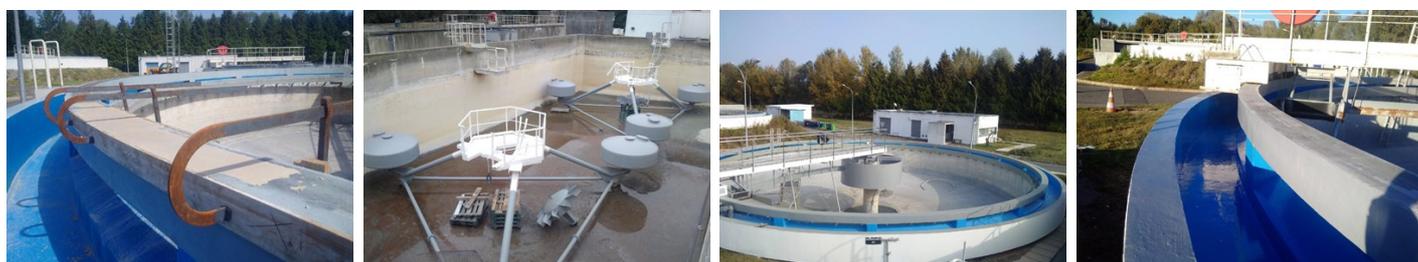
The concrete roller track of this clarifier became damaged during operation and needed to be rebuilt. The floats and turbines had begun to corrode, so required protection from further deterioration.

- \* Concrete repair on the roller track with Belzona 4111 and a former. ,
- \* Protection of the tripods, turbines and floats with Belzona 5811. ,
- \* Final application. ,
- \* Close up view of final application. ,

The broken parts of concrete on the roller track were taken away and the surface of both the track and the clarifier trough were prepared by scarification. Metal components were prepared by grit blasting. After the surface preparation, the concrete was rebuilt using Belzona 4111 with a trowel and a former when needed, in accordance with a modified version of Belzona Know-How System Leaflet TCC-09. The trough next to the roller track was protected with Belzona 5111. The floats and turbines were protected with Belzona 5811.
