Belzona High Temperature Resistant Coating Protects Transition Spools and Vessel

ID: 7850

Industry: Oil & Gas
Application: VPF-Valves, Pipes and Fittings
Substrate: S31803 (Duplex Stainless Steel)
Products: * Belzona 1391T ,

Customer Location: Major Oil company, China/ Kazakhstan
Application Date: 2018/ 2019

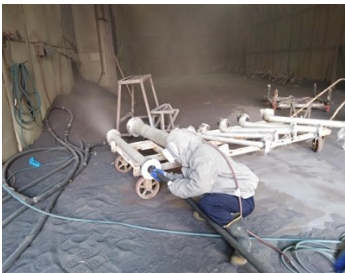
- * Grit blasting in progress. ,
- * 1st coat applied. ,
- * 2nd coat completed. ,
- * HVT testing. ,

The application was carried out in accordance with Belzona Know-How System Leaflet VPF-3. Following surface preparation by grit blasting, the Belzona 1391T was hand applied directly onto the prepared surface.
