# Chimney restored with Belzona

ID: 7856

Industry: Power  
Application: FBC-Fans, Blowers and Compressors

Customer Location: Baltic region, Poland  
Application Date: 2018

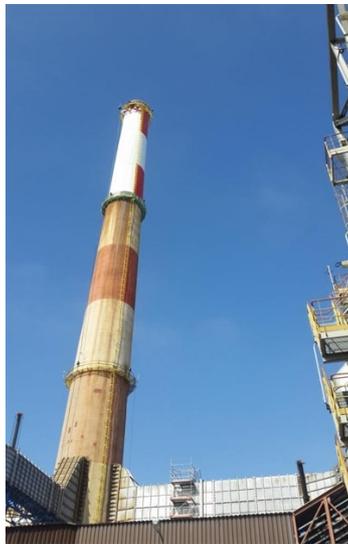
The 120-meter high chimney of the plant's combined heat and power plants required a new more durable coating protection. Previous coatings were very quickly tarnished and damaged.

- \* The deteriorated chimney ,
- \* The application underway ,
- \* The completed job ,
- \* The completed job ,

The application was carried out in Accordance with Belzona System Leaflet FBC-02 The chimney was cleaned, the old paint was removed by abrasive blasting to achieve a good surface profile. Then, Belzona 5911 Ceramic Cladding Conditioner was applied. Two layers of Belzona 5111 (Ceramic Cladding) coating were then applied onto a conditioned surface. The total area to be covered was 4,000 square meters.
