# BELZONA GETS TO GRIPS WITH SAFETY AT AN INTERNATIONAL CONFERENCE CENTRE

Industry: *Buildings & Structures*  
 Application: *FPA-Floor Problem Areas*  
 Substrate: *Ceramic tiles*  
 Products: *\* Belzona® 4131 (Magma-Screed) ,*  
*\* Belzona® 4411 (Granogrip) ,*  
*\* Belzona® 9221 (Surefoot Aggregate) ,*

Customer Location: *International Conference Centre-UK*  
 Application Date: *June 2003*

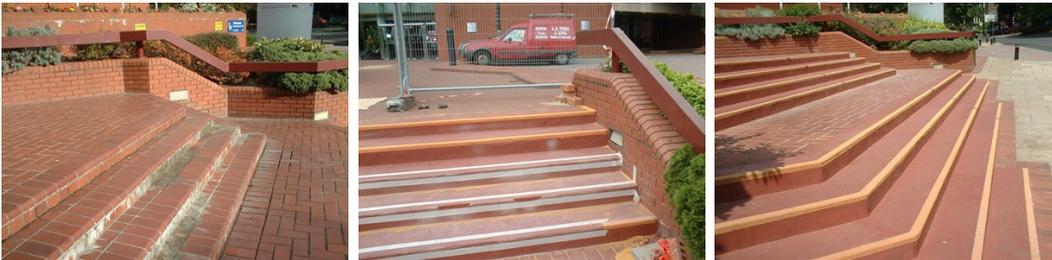
*The finish on the tiles which made up the steps was a slip hazard when wet. In addition to this the steps were subjected to heavy foot traffic and misuse by skateboards, necessitating renovation to a condition reflecting the status of the International Conference Centre.*

- \* Original condition of the entrance steps. ,
- \* Safety Grip areas masked off. ,
- \* The finished application. ,
- \* Application after 6 years of service. ,

The application was carried out in accordance with Belzona Know-How System Leaflets FPA-1 and FPA-8.

The customer was extremely pleased with the aesthetic appearance of the application, which aside from meeting their safety needs, matched the Organisations Logo. After 6 years of arduous service Belzona is still providing excellent performance and the rough surface prevents damage from skateboarders.
