BELZONA BONDS NEW BRACKETS TO TANK ROOF

ID: 7866

Customer Location: Petrochemical Plant, Netherlands
Application Date: September 2018

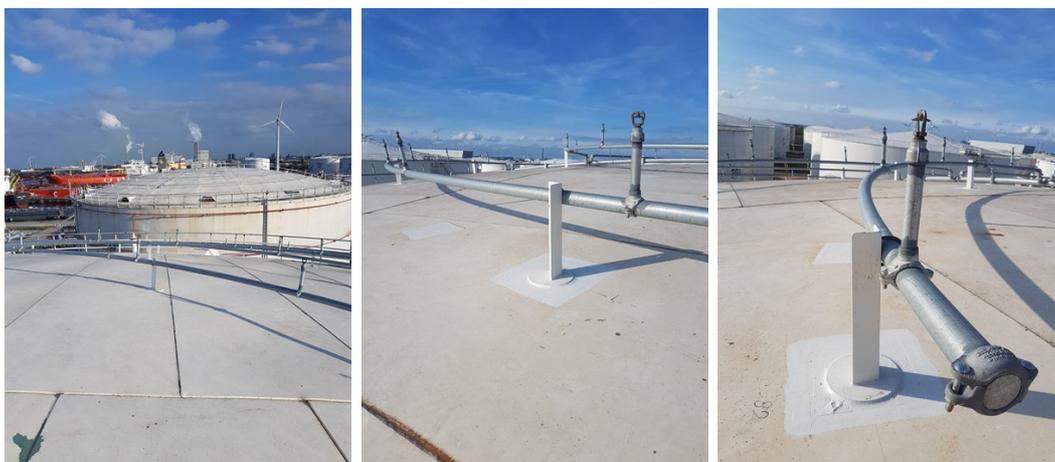
The company needed a solution to bond the brackets of their new water sprinkling and foaming systems on several oil tanks. The problem here was that hot work and grit blasting (due to the dust created) were not allowed on site.

- * 1- Overview of the tank roof ,
- * 2- Final application ,
- * 3- Zoom on a cold bonded bracket ,

For each tank, the substrate was prepared with a dust free blasting system in order to achieve the right surface roughness without generating dust and potential fire hazards near the oil. Then, the brackets were bonded using Belzona 1111. Over 1000 brackets/support were bonded over 7-8 different storage tanks. 8 brackets were bonded on the side of a few tanks, the remaining brackets were bonded on the top of the tanks. The vertical brackets were help in place using magnets and vice mechanisms, while the brackets on the roof were bonded without additional weight or pressure during the curing process.
