Condenser Rubber liner repaired with Belzona

ID: 7868

Customer Location: Power plant - Takoradi, Ghana
Application Date: October 2018

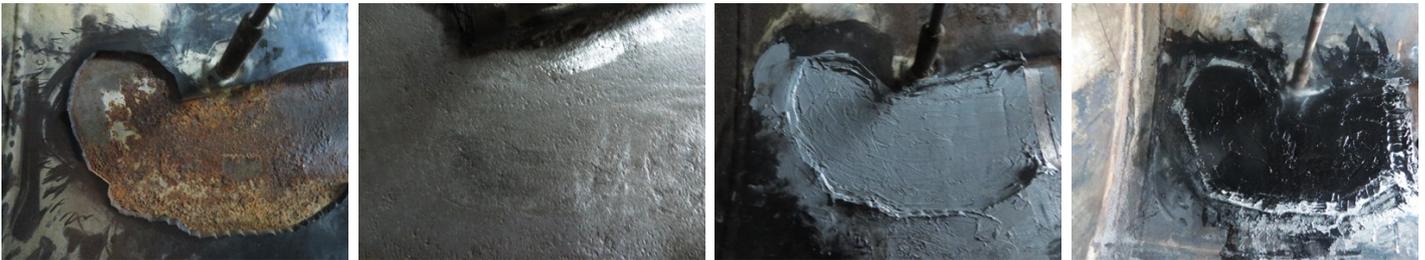
Photograph Descriptions

Existing condenser rubber liner peels off and corrosion starts to attack the metallic surface.

- * Before the surface prep and application of Belzona 2111 and Belzona 1111 ,
- * After Surface preparation using bristle blaster ,
- * After the application of Belzona 1111 ,
- * After view when Belzona 2111 was applied ,

Application was done in accordance with Belzona System leaflets GSS-1 creating gaskets. After surface was prepared, we notice some amount of metal has been lost. Metallic surface was rebuilt with Belzona 1111. Elastomeric conditioner was applied on the next day, then Belzona 2111 (D&A High-Build Elastomer) was applied, using an applicator and brush.

The rubber liner was rebuilt with Belzona 2111 and is currently lasting and performing well when steam condenser is in service. The cost to repair is lower as compared to purchasing a new steam condenser for power generation. Belzona 2111 (D&A High-Build Elastomer) was selected because of the properties with respect to operating parameters.
