1000/700 ALLEN GWYNNE PUMP PROTECTED WITH BELZONA

ID: 787

Industry: Water / Wastewater
Application: CEP-Centrifugal Pumps
Substrate: Cast Iron
Products: Belzona® 1341 (Supermetalgilde)

Customer Location: Local water authority - South Africa
Application Date: July 2006

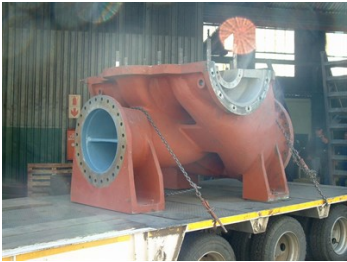
* Pump being delivered to OEM after coating. , * Pump internals , * 9 ton bottom Section , * Pump suction ,

40 Kg of Belzona® 1341 were applied to this pump. This water authority has standardized on Belzona® 1341 for all their water pumps.
